Landsat-6 Failure Investigation Final Report Summary

January 16, 1995

**National Oceanic and Atmospheric Administration (NOAA)
Landsat-6 Failure Review Board**

**Martin Marietta Corporation
Investigation Board**

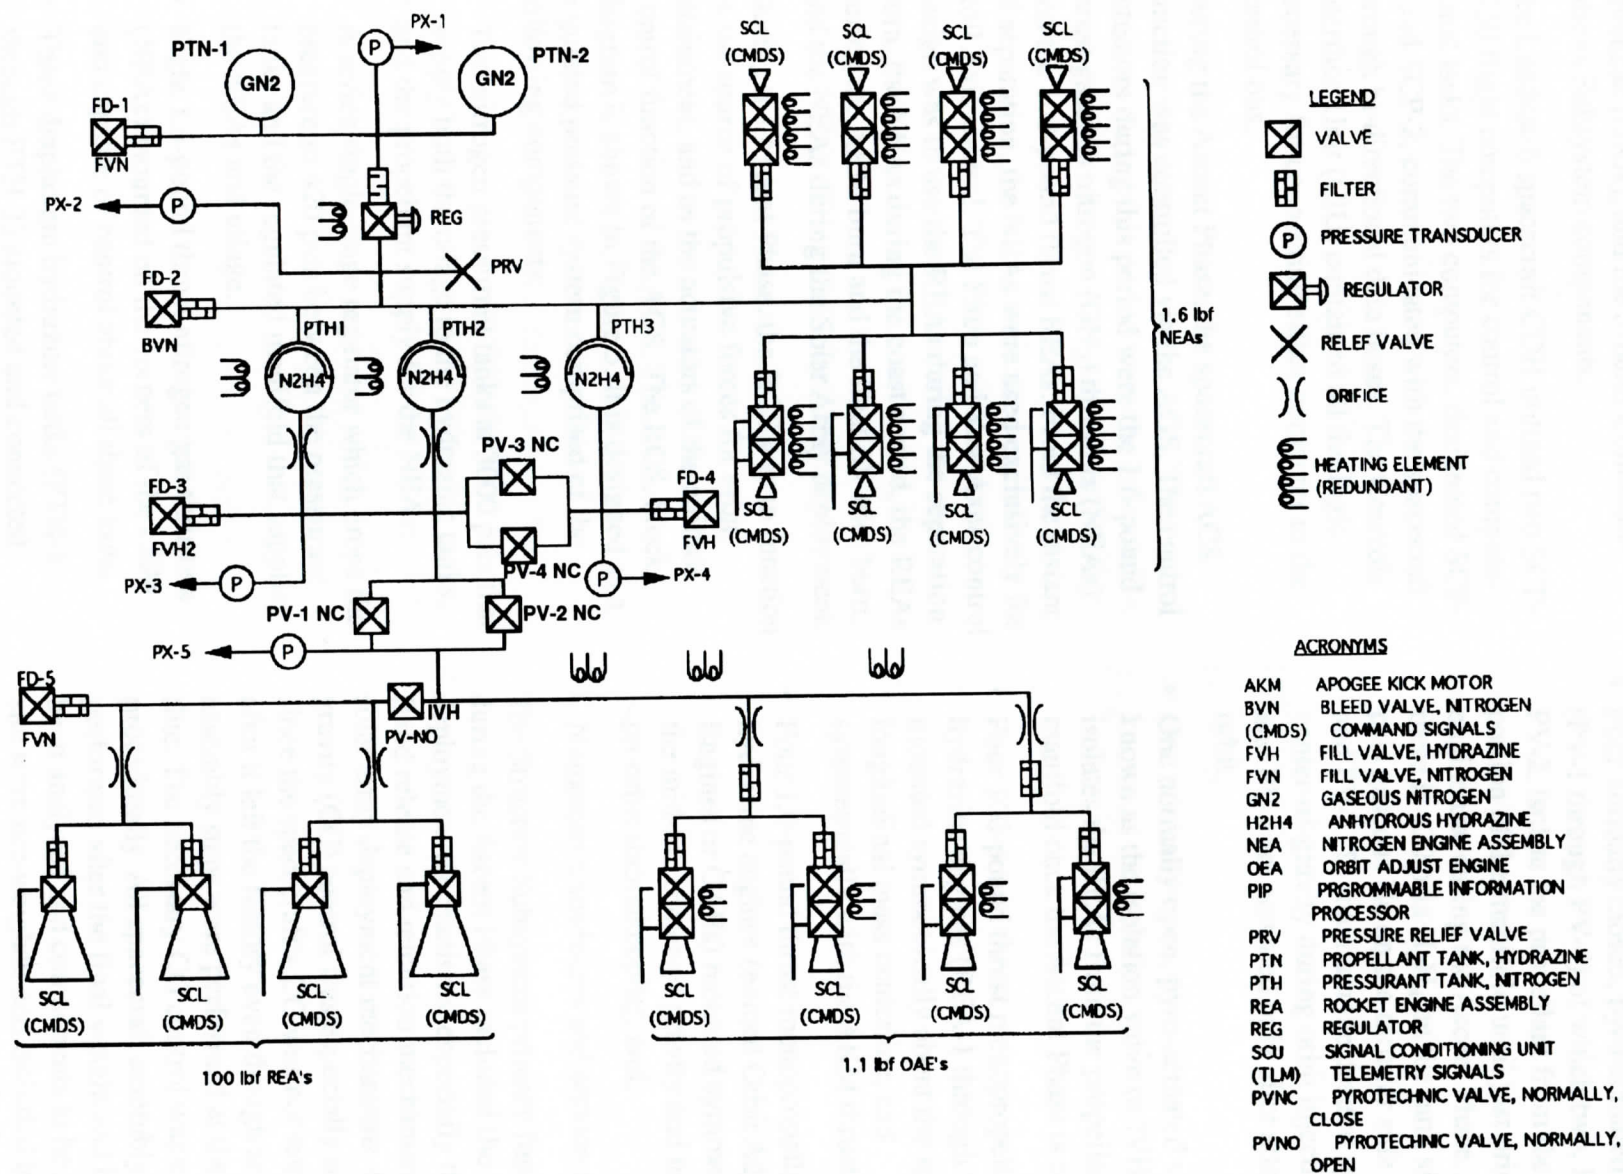
Figure 5. RCS System Block Diagram

the limited supply of pyrovalves. The last series of tests, using hydrazine as the fluid, employed pyrovalves. It should be stressed that the system tests were conducted following exactly the sequence employed in flight. Specifically, (referring to Fig. 5), the manifold from the tanks to the pyrovalves (PV-1 and PV-2) were filled with 420 psia water or hydrazine, while the manifold downstream of the valves to the thrusters (REAs) were filled with 16 psia gaseous helium, simulating conditions from lift-off to beginning of the venting at 18:03:02.5 UTC for the flight (referred to in Section 3.0). Each test began with the 0.5 sec. vent of the He to vacuum through the simulated REAs and upon closing the REA valves, simultaneously activate PV-1 which releases the 420 psia liquid into the now low pressure (1.7 psia) He manifold (assuming PV-1 has functioned nominally). The liquid gets to the downstream side of PV-2 quickly as all the other lines continue to rapidly fill, with short duration pressure spikes created at all the dead ends. PV-2 thus has fuel on both sides of it before it is activated to open 1 sec. after a nominal PV-1.

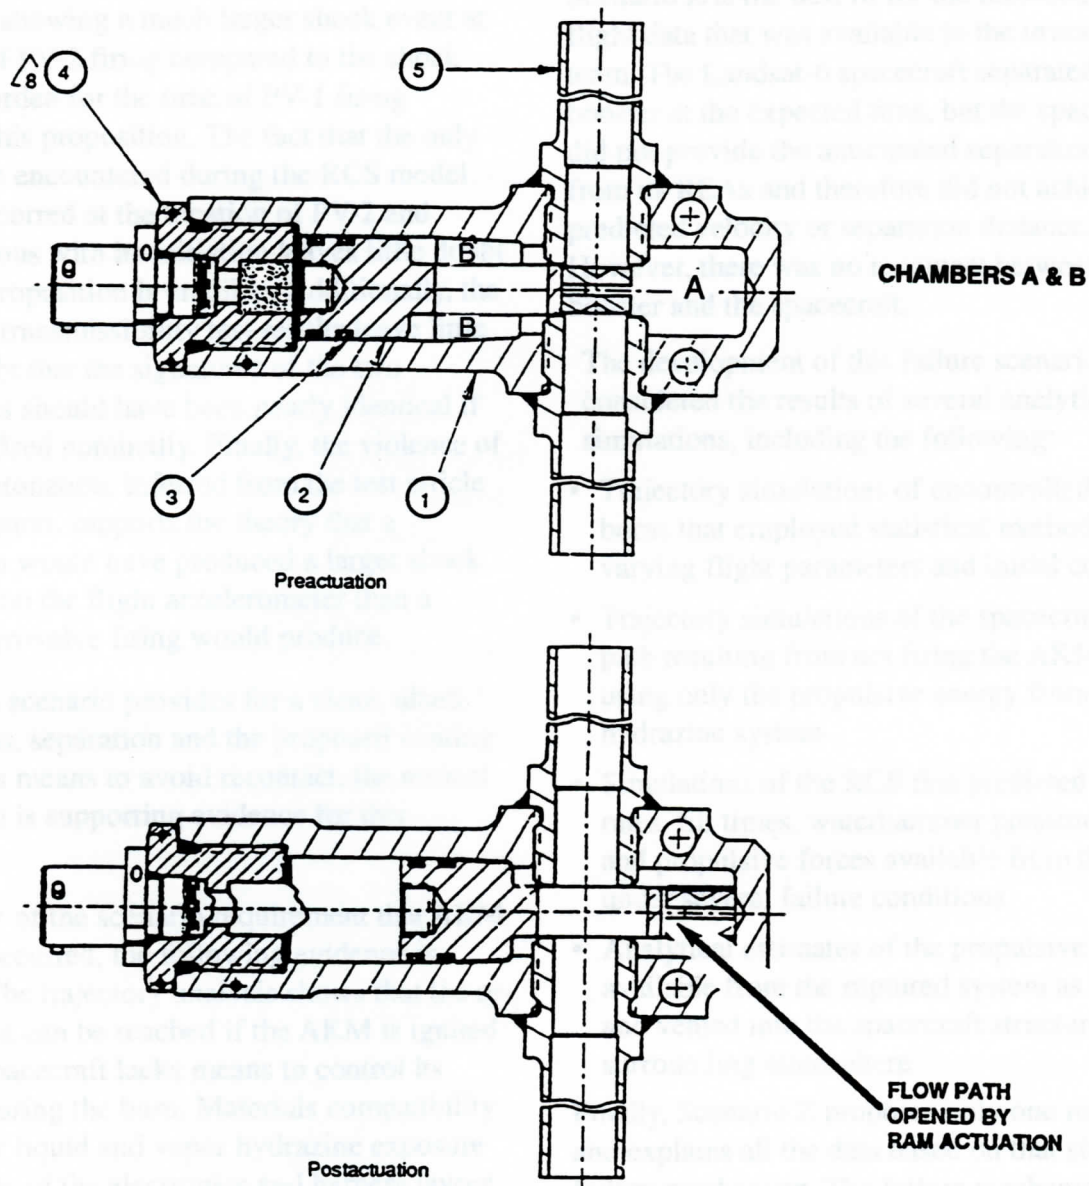
Figure 9. Pyrovalve Assembly—Normally Closed

In a meeting of the Boards prior to the preparation and execution of the high fidelity RCS ground test program it was discovered that air is trapped in chambers within the pyrovalves as they are assembled (A&B in Figure 9). The presence of air (and therefore oxygen) is known to have a significant effect on reducing the ignition temperature of hydrazine vapor. Further, as can be seen in the postactuation configuration of Figure 9, the air in those two chambers are compressed (and heated) during valve actuation and can actually mix with hydrazine and helium that was trapped on the downstream side of PV-2. This mixture of air, hydrazine, and helium gets further compressed by the two high pressure columns of hydrazine converging towards each other into the open valve. The shearing of the flow tube to open it may also result in heated metal ends. In more recent tests of pyrovalve actuation, evidence of hot particles and gases from the explosive charges that initiate and actuate the valve have been seen to blow by the protective O-rings, which offers yet another candidate ignition source.

These possibilities of ignition are consistent with the ground test failure at PV-2 actuation. The difficulty is that there is no analytical, semi-empirical or even empirical theory which quantifies the contributions of each of these ingredients to the ignition and explosive decomposition of the hydrazine. Nor is it even certain that all contributing factors have been identified. Without such a theory, validated by extensive experimental data, it would be extremely risky to alleviate some of the proposed contributors and assume it safe to employ the pyrovalve in this application without numerous high fidelity RCS mock-up tests to account for the non-repeatability of explosion. It is for these reasons that the cause of failure in this most probable scenario is termed "unpredictable mechanism." It is believed that to exactly match the Titan II accelerations during the period from T+395 seconds to T+402 seconds would require direct measurement data from the spacecraft.
